**USAEPG-SIG 920-73**

PINAL REPORT, OPERATIONAL EVALUATION OF

# **EW RECONNAISSANCE SYSTEM** (A/R) <del>W</del>

# FINAL REPORT OPERATIONAL EVALUATION OF THE AIRBORNE EW RECONNAISSANCE SYSTEM (A/R) (U) (Job 33-56-0023)

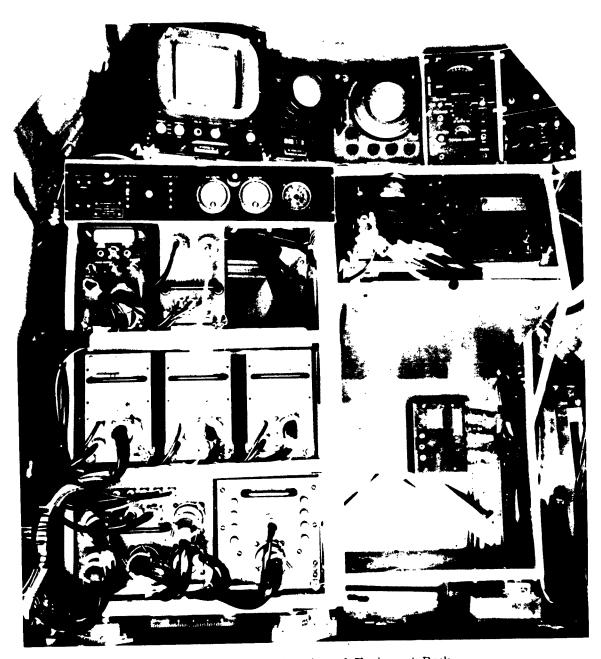
Fig. 1. Operating Console and Equipment Rack

- (1) There is insufficient leg and knee room with the arrangement of equipment as presently constituted. Operators are freer of the distractions of physical tension and can operate more effectively when there is sufficient leg room to permit changes of leg position from time to time and when the knees are not pressed upon by surfaces above them such as the present slanting panel. This deficiency should be corrected to provide a minimum rectangular leg area for the seated operator of 24" (height) X 24" (width) X 18" (depth), instead of the narrow irregular area provided at present. Although space is limited within the aircraft, it is sufficient for achieving this change, especially in view of the equipment rearrangement suggested in subsequent paragraphs of this report.

- (2) The operator is too close to many of the control surfaces to permit easy manipulation of some knobs and switches, particularly those of the AN/APR-14. The present arrangement of equipment has necessitated placement of the operator with the back of his chair flush with one of the workspace walls. He cannot be placed further from the equipment than he is now under the present arrangement. The operator's chest should, however, be no closer than 1' 2" from any control surface. It should be noted in this connection that the parachute, which will be between the operator and the back of his seat, is 5-1/2" in thickness, and distance of equipment from the operator's chest should be planned with this in mind.

- (4) The AN/APA-74 is placed too far from the operator. At those times when it is necessary for the operator to view the screen through the rubber hood, he must lean far forward for several minutes in a severely strained position. The AN/APA-74 should be placed in such a position that the operator has a shorter distance to lean but should still allow for sufficient safe clearance during rough air conditions when the KD-2 camera is attached. (For comment on the KD-2 as a safety hazard see d-(1)-4 below.)

- a. There is insufficent leg and knee room for the operator. This deficiency should be corrected to provide a minimum rectangular leg area of 24" (height) x 24" (width) x 18" (depth).

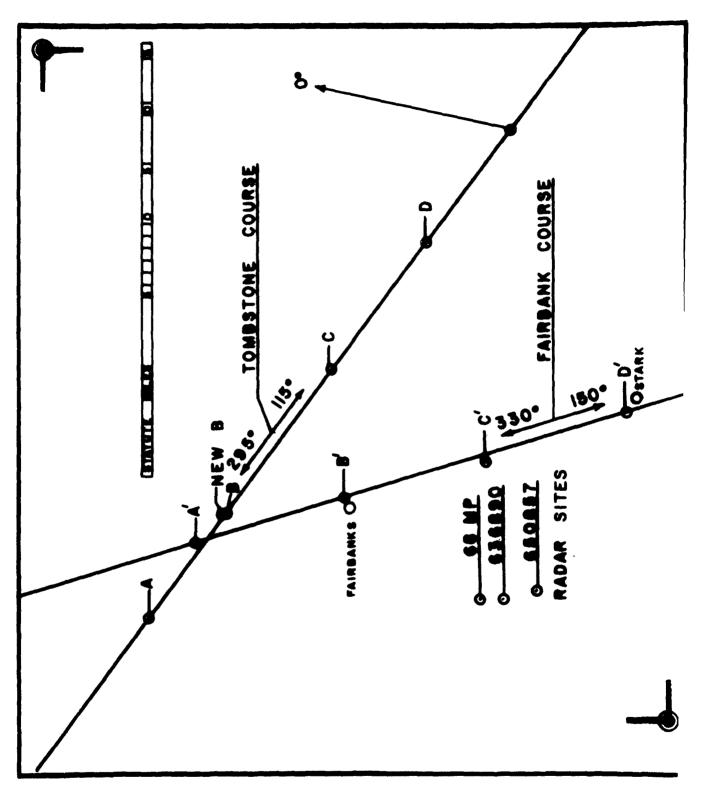
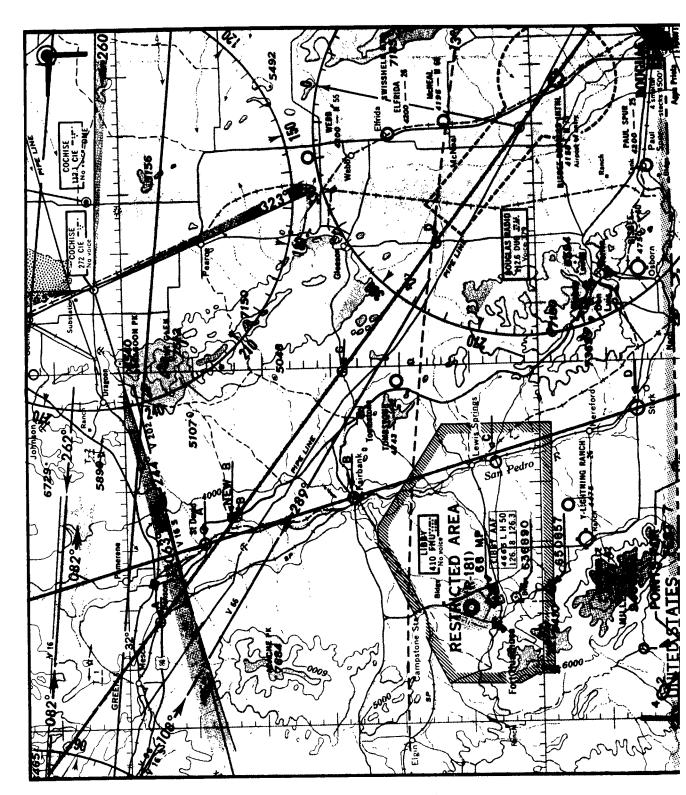
Fig. 4a. Geometry of Test Situations

An AN/TPS-1D radar was sited on Hill 636890 as shown in fig. 4 and put into search operation, searching 360 degrees in azimuth.

The aircraft bearing the A/R System was flown in the area south and west of the Huachuca Mountains (see fig. 4). The presence of the AN/TPQ-8 signal could not be detected unless line-of-sight conditions existed. The operator of the A/R System discounted the possibility of beam bending or refraction. The minimum altitude at which the signal could be received while flying southwest of Miller Peak was  $9{,}000$  feet, and the signal was alternately present and absent while flying at this level along a north to south flight path west of the mountain range. The situation was aggravated by the lack of usable check points when the signal was present.

Four D/F readings were obtained, above the ground points indicated for Test 7 on fig. 4. The readings above these points were as follows:
